RCRA Compliance Inspection Report

U.S. Department of Energy Hanford

Central Waste Complex

April 1-2, 2014

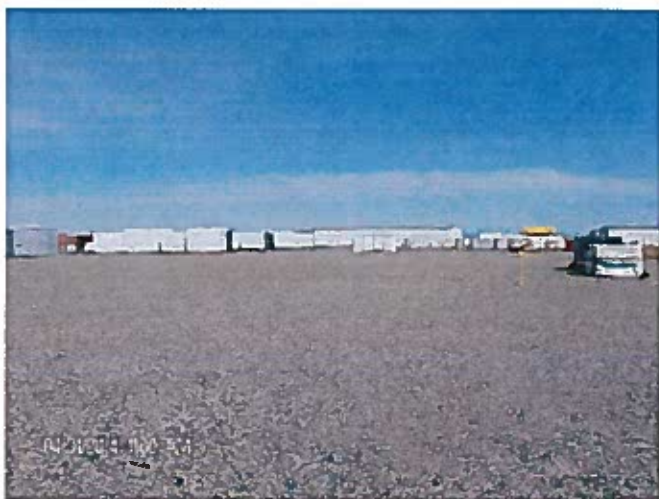
Photo HPIM474 OSA-A looking north from the

During the tour I observed that the CWC unit group consisted of multiple container storage units. Six of the container storage units were outdoor storage areas (OSA). The remainder of the container storage units in the CWC were various sized metal buildings. I observed that the outdoor storage areas are all uncovered gravel pads. According to Mr. Giles the pads are all built on top of native soils with no liner or artificial layer under them. I observed that the pads did not have any curbing or berms to provide secondary containment or to prevent run-on or run-off of storm water (see photos HPIM4747 and HPIM4749 below).

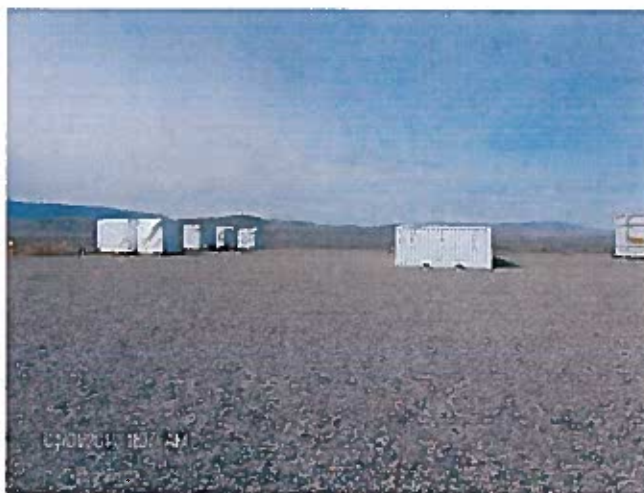
Photo HPIM4749 looking southeast showing no

South edge of the pad.

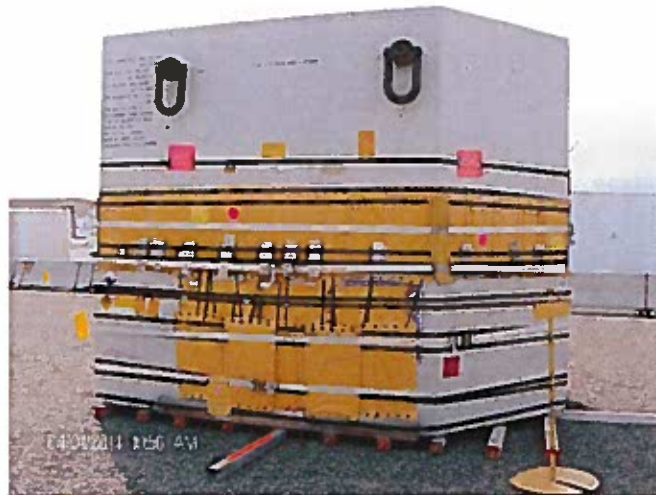
Photo HPIM4742 Box containing Tank D-10

1 In OSA-F we observed a large box that we were told by Mr. Giles contained Tank D-10. The box was irregular in shape and approximately 500 cubic feet in volume. Mr. Giles explained that Tank D-10 had originally been used in the redox process at U-Plant. As part of a CERCLA action Tank D-10 was placed in the box and moved to CWC in September of 2011. Once at the CWC, Mr. Giles continued to explain, the large box containing Tank D-10 was placed in the OSA-F.

At the time of the inspection the large, 500 cubic feet box we observed in OSA-F was clearly marked with the words "hazardous waste". The container also had a label on it that indicated the waste in the container had been designated as ignitable characteristic dangerous waste, D001. The risk label on the container indicated that the waste was an oxidizer and corrosive (see photo HPIM4742 below). According to Mr. Giles the 500 cubic feet box had been placed in storage at CWC in September of 2011. The D001 dangerous waste in the 500 cubic feet box had been in storage for more than one year.

Through the TPA, EPA and Ecology have agreed to allow storage of hazardous waste, at the Hanford facility, for periods exceeding one year, provided that the waste is on an agreed schedule for treatment to meet LDR standards. On May 2, 2014, DOE responded to an EPA information request regarding numerous containers of mixed waste or dangerous waste that had been in storage for over a year. In that response, DOE provided general information as to whether or not containers at the CWC met the conditions for greater than one year storage allowed in the TPA. My review of this information found that DOE stated in general terms that all containers at the CWC that had been in storage for more than one year met the agreed to conditions, but they did not specifically identify the box containing the D-10 tank as one of these compliant containers.

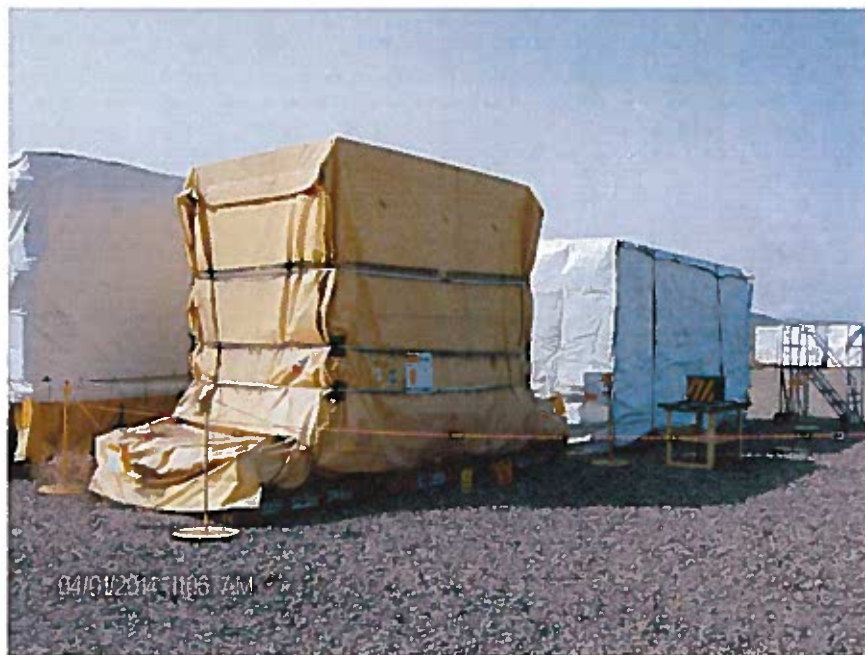
Photo HPIM4746 Tarp covered waste containers in OSA-A

During our inspection of OSA-A, I observed several large rectangular containers that are referred to by facility personnel as "burial boxes." Mr. Giles told us that these boxes each have a capacity of several hundred gallons and most of them contain radioactive mixed waste or dangerous waste. Mr. Giles said that there were 122 of these boxes in OSA-A at the time of the inspection. I observed that many of these boxes had been covered with tarps. Mr. Giles told us that these burial boxes were covered by tarps pursuant to a consent agreement with Ecology. I saw that the tarps were made of heavy synthetic material and were securely tied down around the sides of the containers so that they completely covered the containers all the way to the ground. It was not possible for me to inspect the containers under the tarp without first removing the tarp. Mr. Giles confirmed that the containers could not be inspected unless the tarps were removed. He further explained that because the tarps were very heavy and were tightly secured, it was not possible to look under the tarps and observe the condition of the actual container during weekly inspections. Mr. Giles verified that, because of this inability to look under the tarps, when CWC employees conduct the weekly inspections they only assess the condition of the tarps and are not looking for deterioration of the containers caused by corrosion or other factors. He said that they would only detect leaks if the leaking material was running out from under the tarps. Containers of hazardous waste are required to be inspected weekly to ensure that they are not leaking and there is no deterioration of the containers caused by corrosion or other factors (see photo HPIM4746).

I discussed the fact that because the containers in OSA-A are covered with heavy tarps, it is not possible to see the actual walls of the containers for the purpose of weekly inspections to assess the condition of the container.

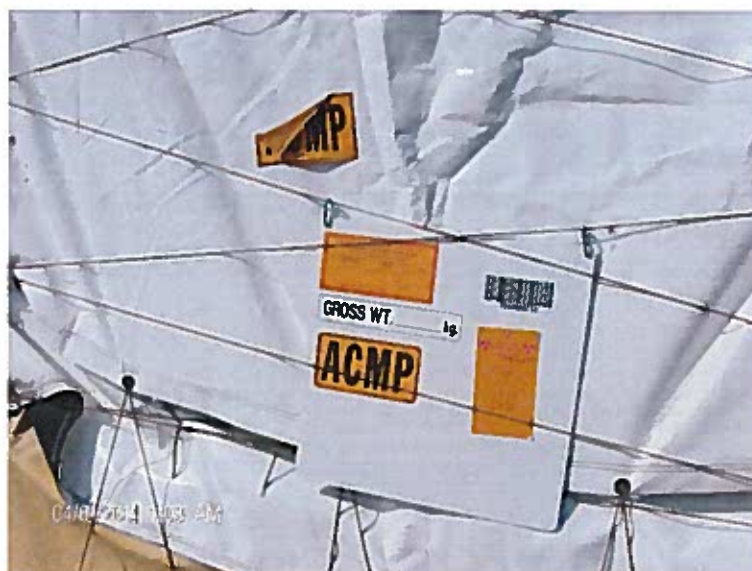
Photo HPIM4750 Metal plate holding labels for waste container.

Attached to the outside of each tarp covered container inside the OSA-A, I observed a square metal panel. The panels contained, among other things, hazardous waste and risk labels. Mr. Giles explained that these panels were used for displaying all of the required labeling for each container (see photo HPIM4750). It was unclear to the inspection team if each container is also labeled under the tarp or only on the panel attached to the exterior of the tarp.

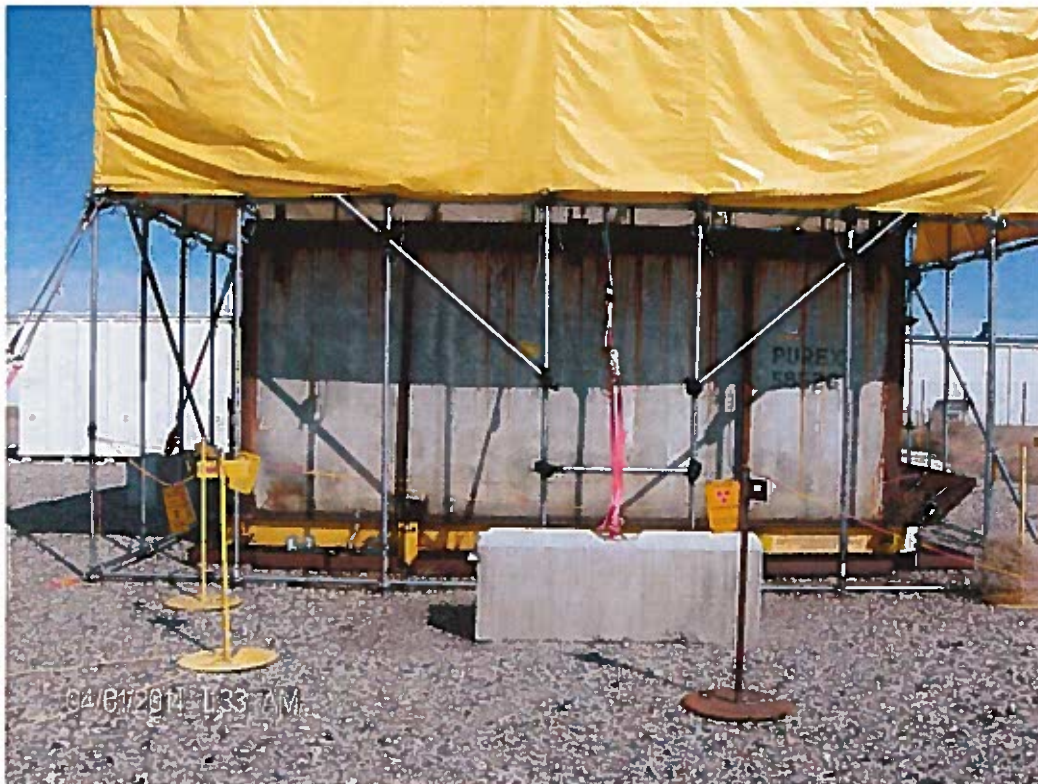
Photo HPIM4756 Container 231ZDR-11 showing rusted trays under yellow steel frame

4 In the northeast corner of OSA-A I observed container 231ZDR-11. This container was the subject of an Ecology enforcement action in January, 2014. In that action, Ecology alleged that not only had liquids been released from this container but the response made by DOE and its contractors to address the leaks from this container were inadequate. Mr. Giles explained that although the DOE had determined that container 231ZDR-11 was leaking in February of 2012, waste still remained in container 231ZDR-11 instead of being transferred to a container that is in good condition. He further stated that the container had not been moved since the leakage was first noted.

Unlike other containers in OSA-A, 231ZDR-11 was under a plastic cover that did not reach all the way to the ground. The plastic tarp over this leaking container was approximately seven feet off the ground. Instead of the tarp being secured at the base of the container like the other covered containers in OSA-A, the plastic cover on 231-ZDR-11 was supported by a metal frame. Because all of container 231-ZDR-11 was visible I was able to see that this rectangular container had walls made of concrete supported by a metal frame.

5 The container was supported about six inches above the ground by a steel frame with legs. I observed several rusty metal trays under the steel frame around the sides of the container. The trays were approximately two feet by three feet and approximately four inches deep (see photo HPIM4756 below). Mr. Giles explained that the purpose of the trays was to collect storm water that came in contact with the box as well as collect any materials that leaked from the box. He said that any liquid that collects in the trays is pumped out into a container and managed as hazardous waste. It wasn't clear whether the trays were considered secondary containment or accumulation containers. It appeared that the trays were not large enough to hold storm water from a twenty-five year storm event of twenty-four hour duration as required by the secondary containment rules. If they were considered accumulation containers they were not closed and not marked with the words "Hazardous Waste" or "Dangerous Waste" nor were they marked with the risk associated with the waste.

6 Inside two of the trays under container 231ZDR-11 I observed two clear plastic containers that each had a volume of approximately five gallons. Each five gallon container appeared to be connected to container 231ZDR-11 by a plastic hose. Mr. Giles explained to me that wicking material had been attached to the frame around the bottom of container 231ZDR-11 where leaking had been observed. Mr. Giles told me that the wicking draws any moisture or leakage from the frame and conveys it into the tubes which then drain the collected materials into the five gallon containers in the trays under container 231ZDR-11. Mr. Giles said that the containers were pumped out every couple of months. The liquid that is collected is managed as hazardous waste. The five gallon containers had no labels on them and were not marked with the words "Hazardous Waste" or "Dangerous Waste". They were also not marked or labeled to identify the major risks of the waste being accumulated in them (see lower left hand corner of container in photoHPIM4756 above).

21. HPIM4754 - Another view of a large box of mixed wastes (designated as 2312DR-11) in the Northeast Corner of Storage Area A.
22. HPIM4756 - Another view of the large box of mixed wastes (designated as 2312DR-11) showing the hoses and jugs for collecting leaking fluids from within the outer secondary containment (lower left section of the box) in the Northeast Corner of Storage Area A.

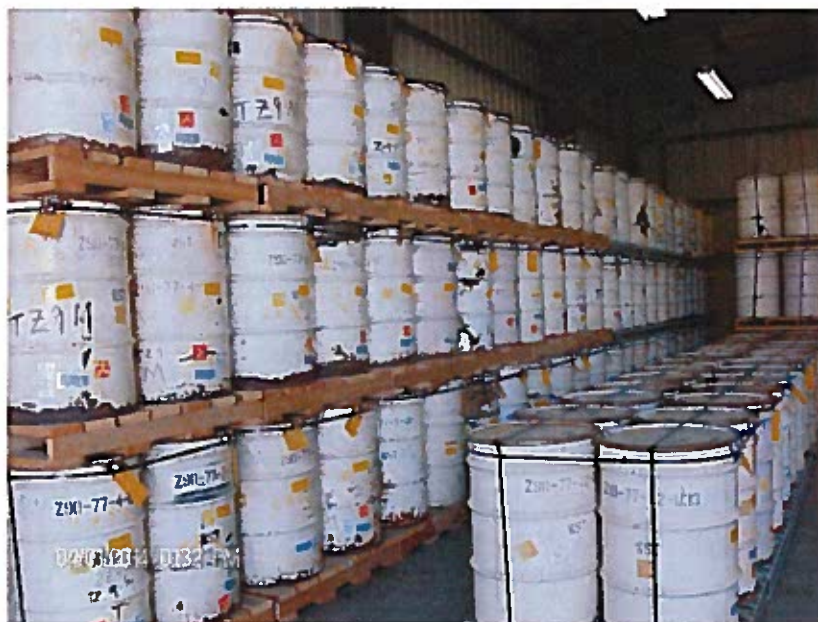
Photo HPIM4768 Corroded drums in building 2402WB

In building 2402WB we observed several hundred drums that Mr. Giles said contained mixed waste contaminated soils. I did a rough count and found approximately 288 of the drums that had corrosion (rust) all the way around the bottom ring and in patches up the sides of them (see photo HPIM4768 below). Mr. Giles said that they had come out of the burial ground with the corrosion on them. He said that instead of immediately transferring the contents to containers in good condition, they visually monitor them during the weekly inspections and if the corrosion on a drum gets worse they would place the drum on the Watch List.

32. HPIM4767 - View of three additional drums of mixed wastes showing corrosion in Bldg. 2402-WB.
33. HPIM4768 - Overview of additional drums of mixed wastes showing corrosion in Bldg. 2402-WB.

I mentioned the corroded drums in 2402 WB. I said we would need to review the documentation regarding the management of these drums before we could make a compliance determination.
